Manhole Inspection Summary

Manhole # S43KK_049MH

Record Plat: **43KK** Node: **049** Status: **Found**

Location Address: **DURMAN**

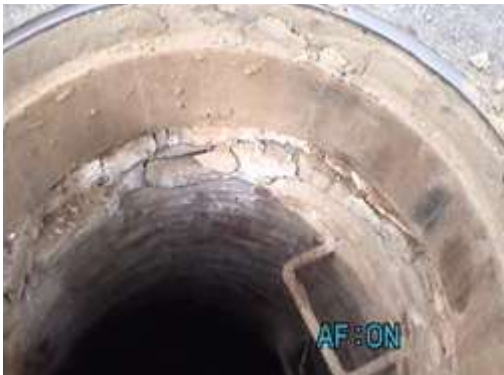
Defect 2

Condition: ☐ Sound ☐ Cracked ☐ Root Intrusion ☒ **Loose Brick** ☐ Deteriorated

Loose bricks

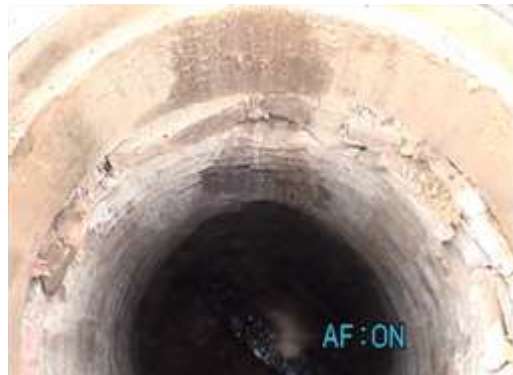
Defect 1

Frame Offset: **1** (in.) Condition: ☐ Sound ☐ Cracked ☒ **Leaks**

Frame leaks

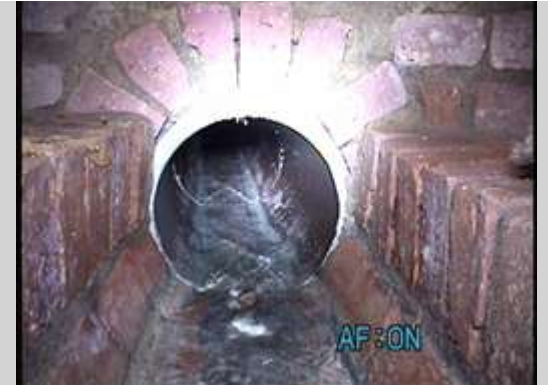
12 O'Clock Outflow

8 in. Circular Gravity Sewer
Pipe Out @ 12 O'Clock

Pipe Height: **8.4** (in.) Rod and Bar (Angled)
Pipe Material: **Clay** ☐ Pipe Lined
Invert Depth: **12.30** (ft.) Flow Characteristics: **Fast**
Deposits: ☒ None ☐ Mud ☐ Sludge ☐ Debris ☐ Grease
Silt Depth: (in.) Deposits Extent:
Infiltration: **None** Pipe Seal Cond: **Sound**

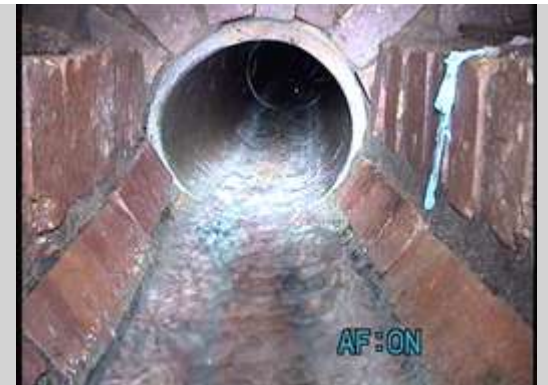
5 O'Clock Inflow

8 in. Circular Gravity Sewer
Pipe In @ 5 O'Clock

Pipe Height: **8.4** (in.) Rod and Bar (Angled)
Pipe Material: **Clay** ☐ Pipe Lined
Invert Depth: **12.25** (ft.) Flow Characteristics: **Fast**
Deposits: ☒ None ☐ Mud ☐ Sludge ☐ Debris ☐ Grease
Silt Depth: (in.) Deposits Extent:
Infiltration: **None** Pipe Seal Cond: **Sound**
